Darebin Creek News

Friends of Darebin Creek

October 2008

Waterwatching Darebin Creek by Michael Sephton

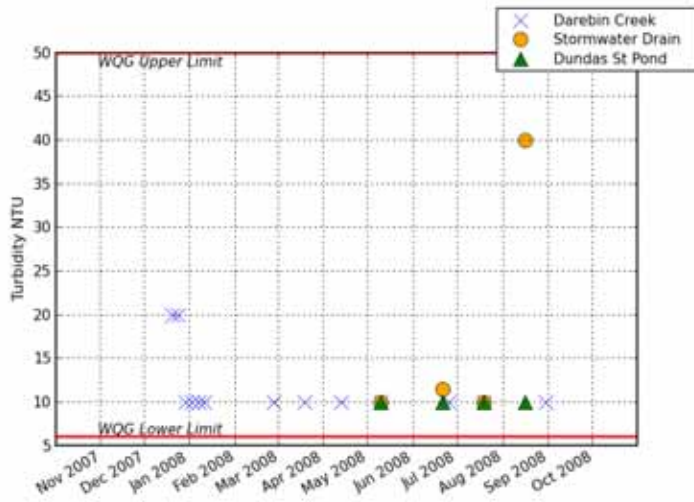
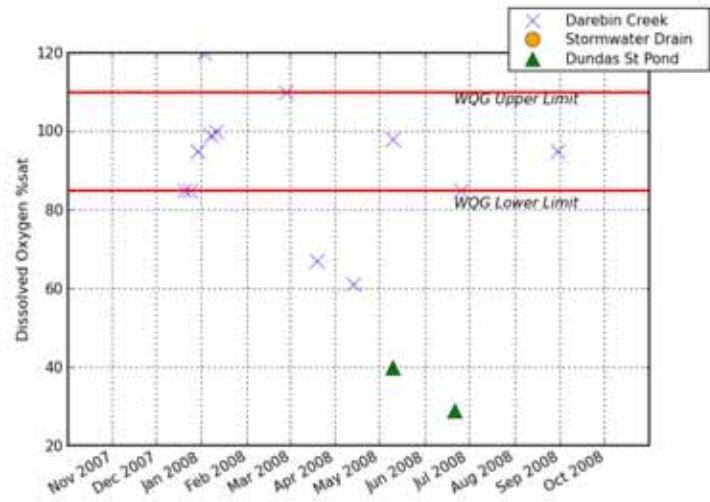
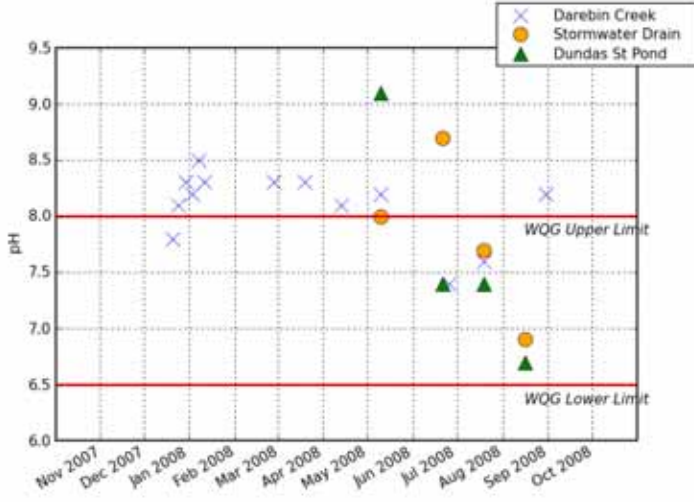
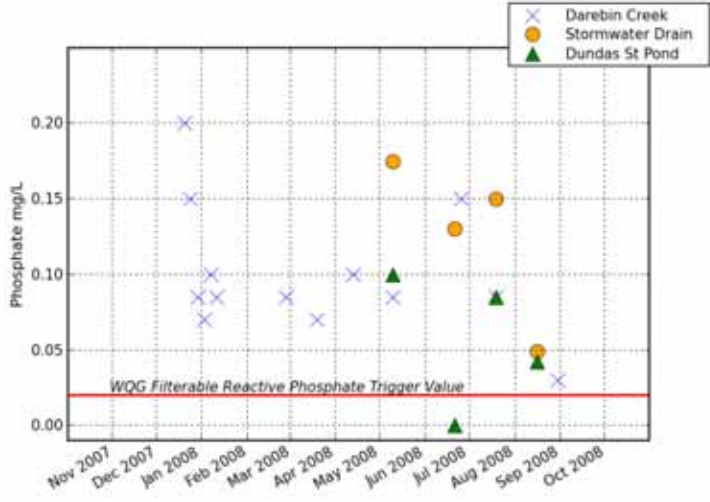
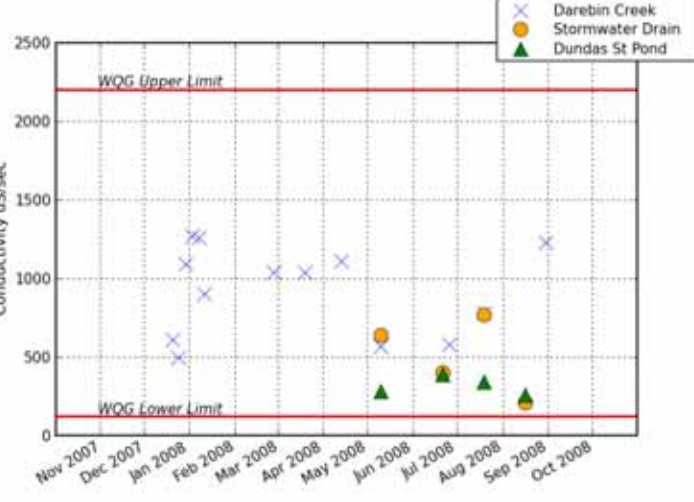
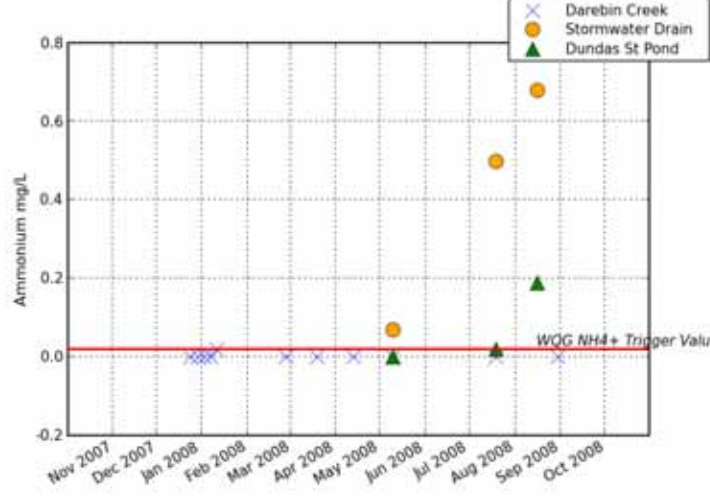
The graphs below present the data for Turbidity, pH, Conductivity, Dissolved Oxygen, Phosphate and Ammonium for the 3 sites over the course of the project. The lines marked WQG Upper Limit, Lower Limit and Trigger Values are for 'slightly-moderately disturbed' lowland rivers from a report by the Australian and New Zealand Conservation Council (ANZECC) and Agriculture and Resource Management Council of Australia and New Zealand (ARMCANZ) titled "Australian and New Zealand Guidelines for Fresh and Marine Water Quality (2000)" (WQG).

It is clear that turbidity measured in the stormwater drain has been higher than that measured in both Darebin Creek and the Pond. The graph of pH is interesting because unlike for Turbidity and Conductivity, the measured values for the Creek frequently exceed the WQG upper limit. It's interesting that the WQG state that the pH is '*naturally very variable among and within ecosystem types and seasonally, and natural biological communities are adapted to the site specific conditions.*'

Looking at the graphs of Dissolved Oxygen (DO), it's clear that the Pond has much lower DO values, probably due to the fact that the water is relatively stagnant. The DO values measured at the Creek were mostly within the range specified in the WQG. There are no values for the stormwater drain, since DO was not measured at that site.

Phosphate values have been found to regularly exceed the trigger value specified in the WQG at all 3 sites. Ammonium values in the Creek have been lower than the WQG trigger value, while higher values have been measured in the pond, and much higher values of ammonium have been measured in the stormwater drain.

The direct applicability of these guideline values to Darebin Creek may be limited due to the fact that much of its catchment is urban. In terms of the WQG, Darebin Creek may be closer to 'a highly disturbed ecosystem' than a 'slightly-moderately disturbed ecosystem'. Indeed the WQG state that 'The physical and chemical trigger values are not designed to be used as... threshold values at which an environmental problem is inferred if they are exceeded'. The trigger values are defined by the guidelines as 'concentrations... below which there is a low risk that adverse biological effects will occur'.

The guidelines also note that if measured values exceed the trigger values, often site specific investigations may be useful to determine if there is a problem.
